Mwoakilloa Atoll

FRESHWATER RESOURCES AND THEIR
USAGE, STATE, AND INFRASTRUCTURE

Danko Taboroši, Ph.D.
Maricruz Sánchez Collazo

October, 2010

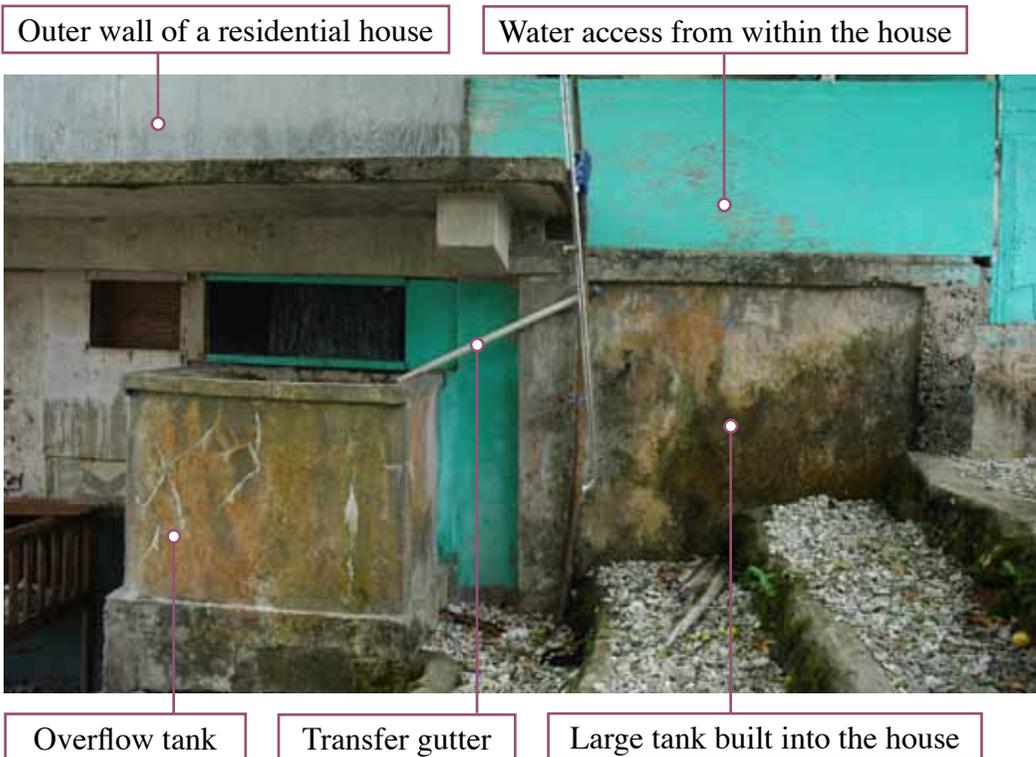
Fig 13
Built-in water storage tanks.

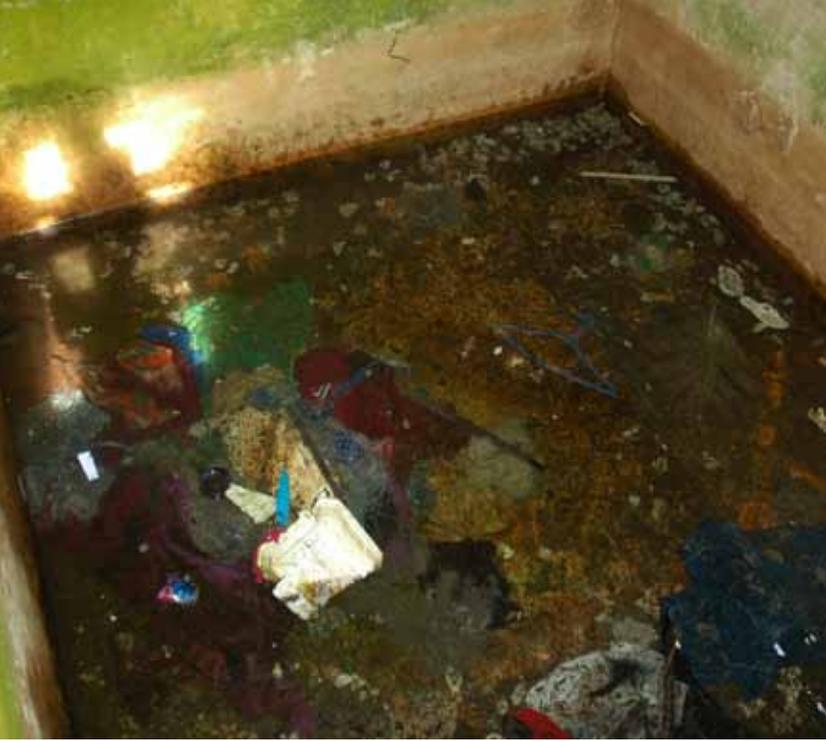
Fig 19
Examples of cesspools in water tanks of abandoned households.

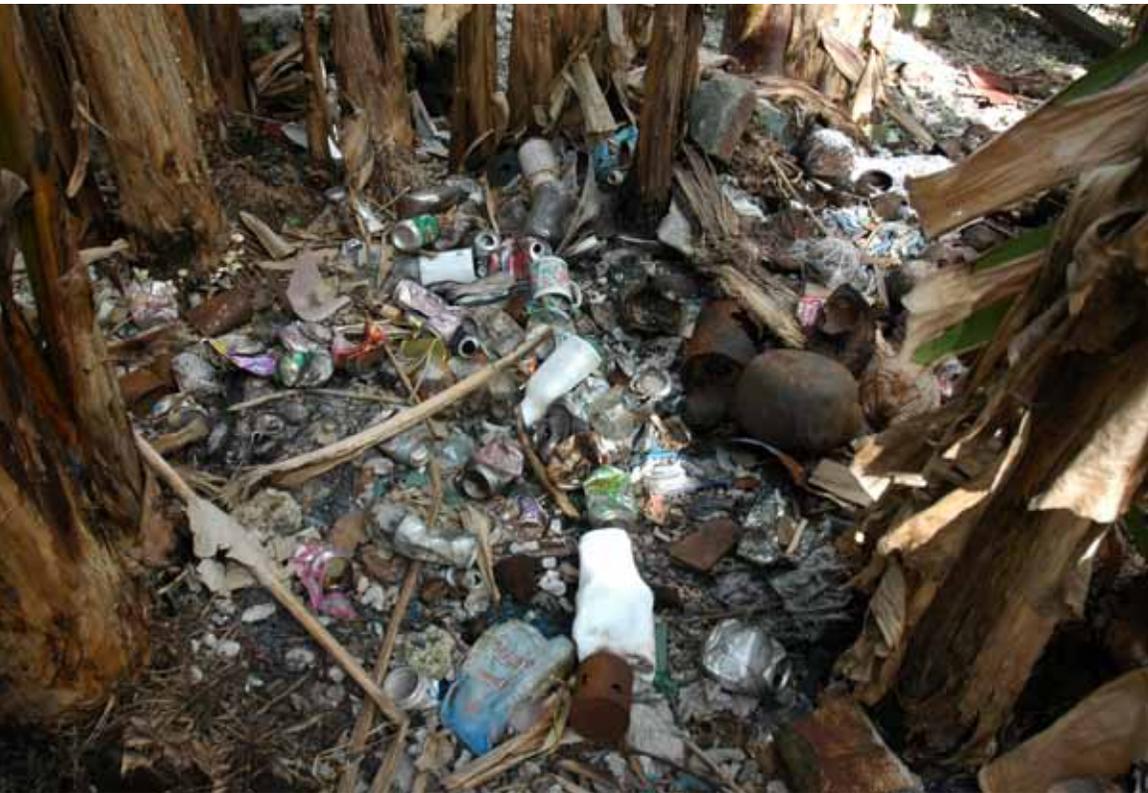
Fig 26
Garbage pile
next to a
particularly
unkept
household.
