RECONNAISSANCE LEVEL INVESTIGATION

OF SALT-WATER INTRUSION ON KUTTU ISLAND, SATAWAN ATOLL, TRUK STATE

UNIVERSITY OF GUAM

Technical Report No. 48

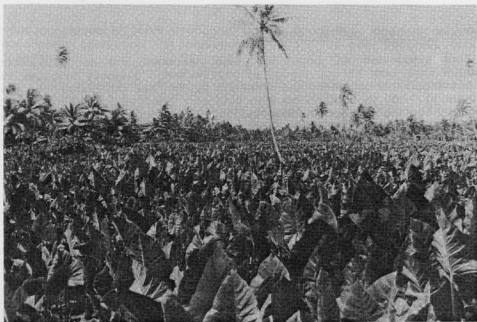
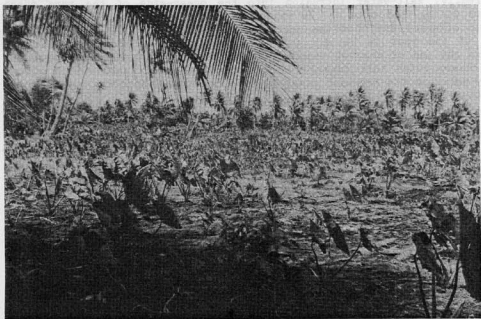
Figure 10. Comparison of unaffected (top) and affected (bottom) areas within the taro patch.

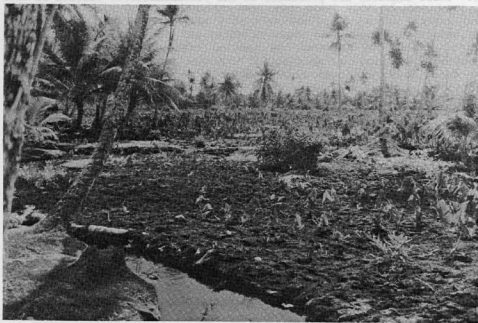
Figure 11. Comparison of areas within the taro patch underlain by fresh (top) and brackish (bottom) groundwater.
