Mwoakilloa Atoll

FRESHWATER RESOURCES AND THEIR
USAGE, STATE, AND INFRASTRUCTURE

Danko Taboroši, Ph.D.
Maricruz Sánchez Collazo

October, 2010

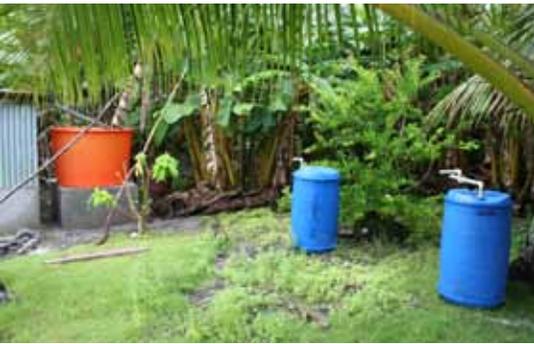
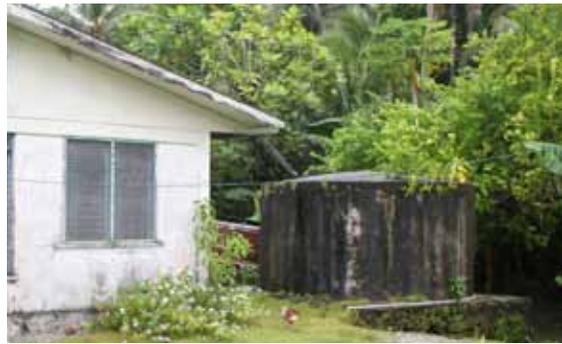
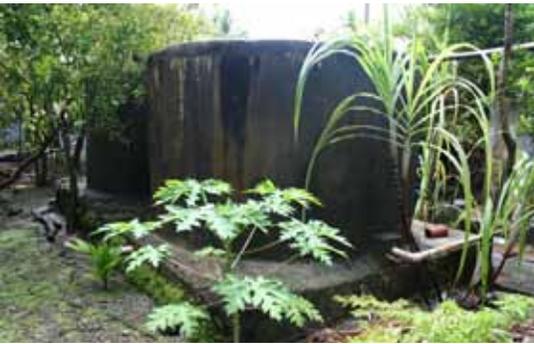
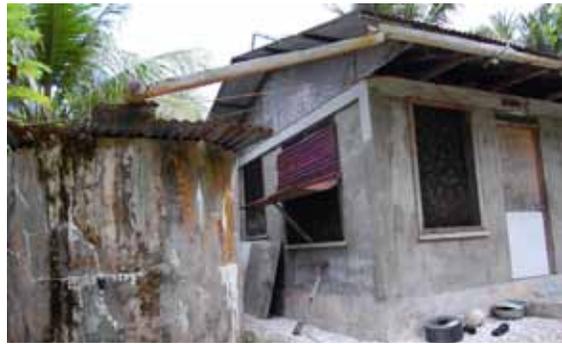
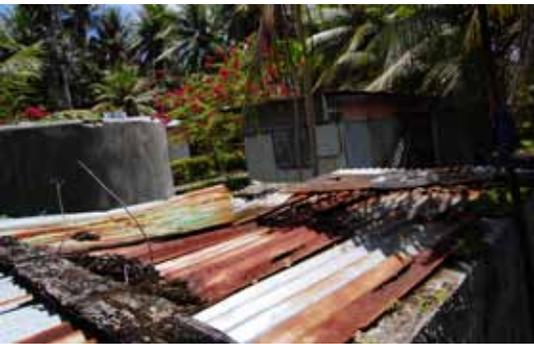
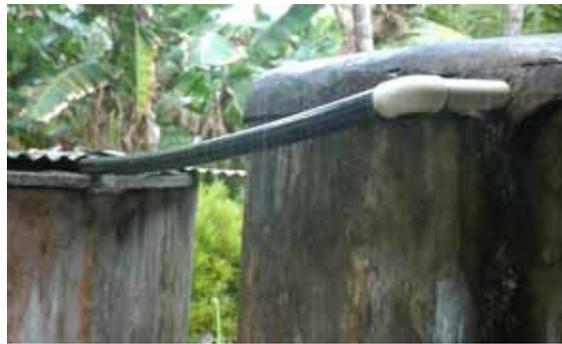
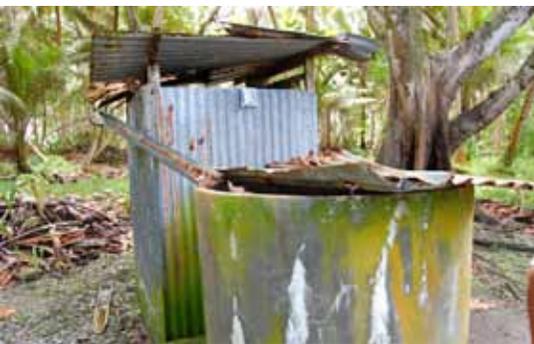
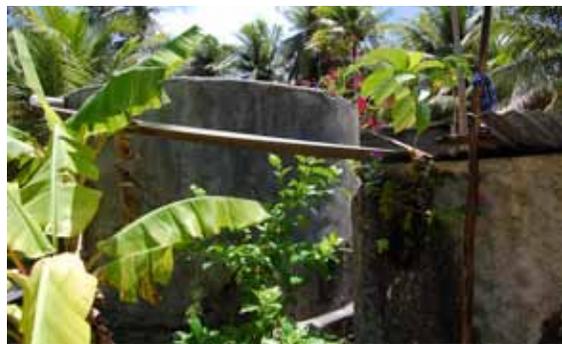
**Fig 18 (opp.)
Examples
of water
catchment
systems on
Mwoakilloa.**

Traditional cisterns made of coral rocks and quicklime (heated pulverized coral mixed with water and resembling cement) used to exist on Mwoakilloa in the past. We did not see remnants of such structures but were told by many people that their ‘grandparents used to make them’. They must have appeared similar to rectangular tanks made of concrete that we have

observed built-in into many houses. Not all, but a substantial number of households have such tanks. Some of them have open top surface and look like pools, accessible from within the house. These tanks were custom-made by the owners at the time houses were built. They occur in various dimensions and volumes and represent unique type of water storage tanks rarely seen on FSM atolls. The authors have considerable experience in the Outer Islands and have observed this type of tanks only on Mwoakilloa and Pingelap.

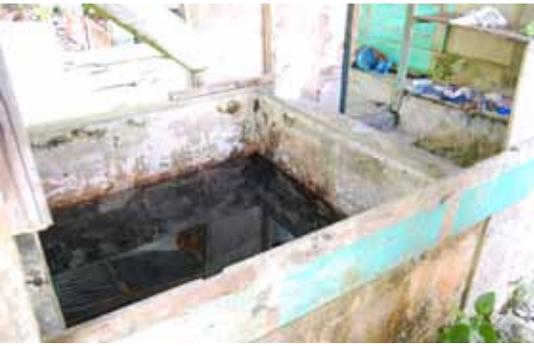
**Fig 18 (opp.)
Continued.
Examples
of water
catchment
systems on
Mwoakilloa.**

During our household survey it quickly became evident that a large number of homes on Mwoakilloa are not inhabited. Some appear to have been vacant for relatively short periods of time -- from a few months to a few years -- but others are clearly abandoned and have not been kept up for many years. By extension, the water storage tanks possessed by such households are also abandoned and left to decay. Many such tanks could be cleaned, repaired, and put to good use.

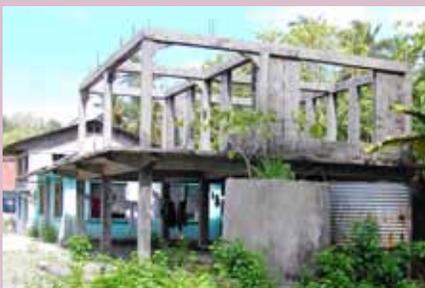
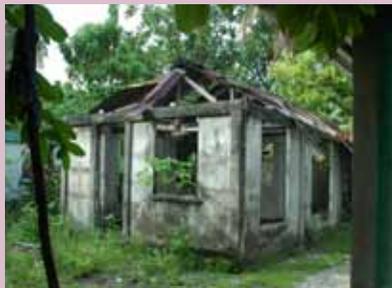
We have observed tanks filled with cesspools of polluted water, floating scum, and various organic waste. They enable completion of the life cycle of mosquitoes and possibly other vectors of contagious diseases.

Fig 19
Examples of cesspools in water tanks of abandoned households.

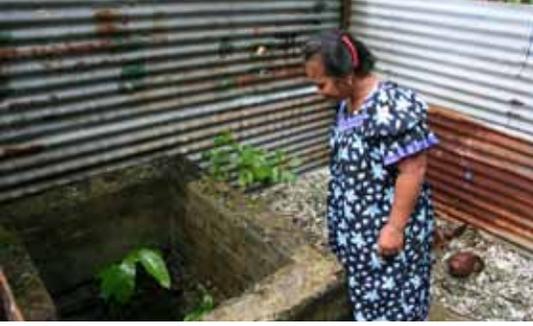
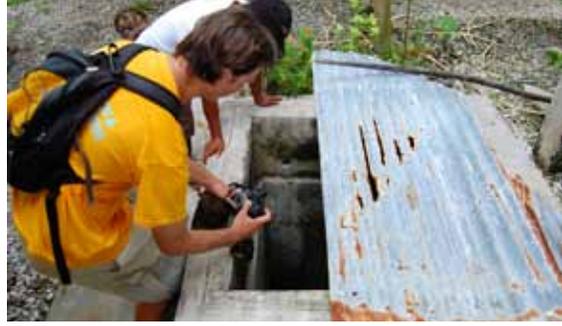
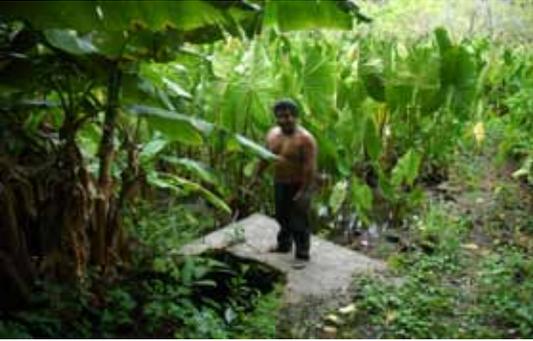
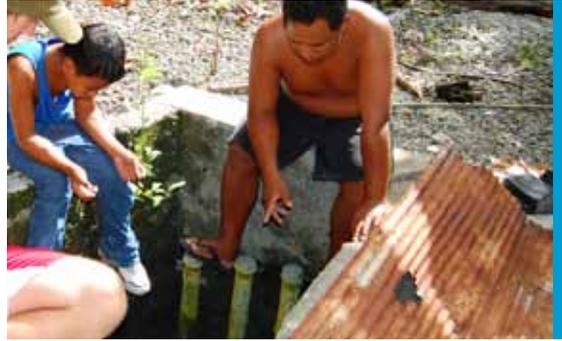
There is a driven well not far from the school site. Two additional driven wells were discovered. Residents do not have much information regarding these wells and do not use them. They are actually a remnant of work by Stephen Anthony, from the United States Geological Survey (USGS), who installed them in 1988. Each well has three metal pipes sticking out of the bottom

Fig 20 (opp.)
**Investigating
wells on
Mwoakilloa.**

-- essentially a cluster of three separate wells bracketing the freshwater lens at different depths. They used to be operated using pumps, which were later broken and removed, so the wells currently see no use. We could not locate the other driven wells made by USGS. Six were supposed to have been drilled around the taro patch. Residents report that this had some effect on the taro patch and interpret the wilting of the taro around the patch perimeter to be a consequence of well drilling.

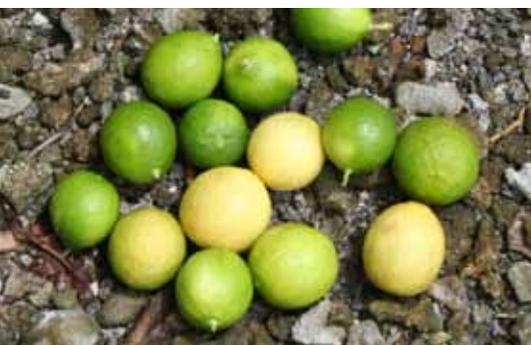
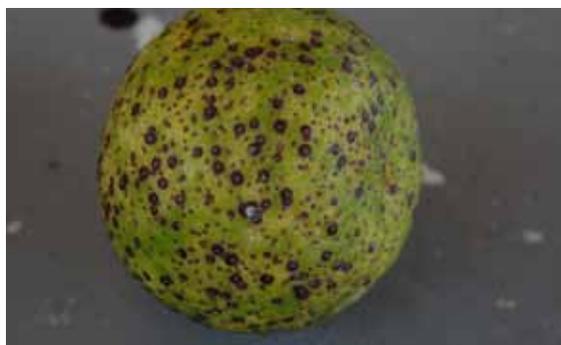
Fig 24
Lemon
fruits from
a healthy (a)
and diseased
tree (b).

residents indicate that this is caused by a small flying white insect. Undersides of leaves may be covered by white powder and fruits develop dark blotches. Such fruits are not consumed. Affected plant may die.

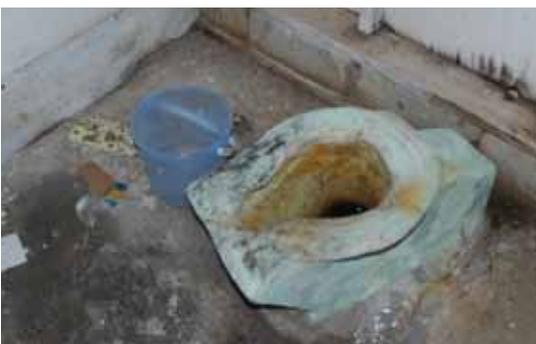
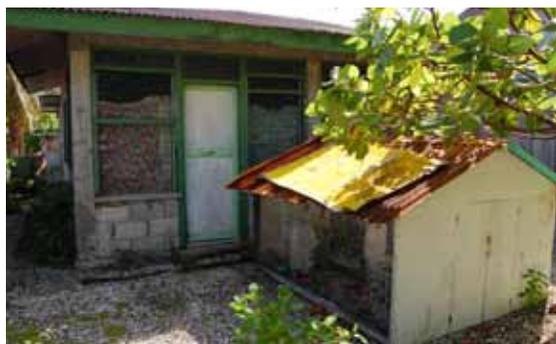
Fig 27
Interior of
a toilet (a).
Gravesite
adjacent to a
house (b).

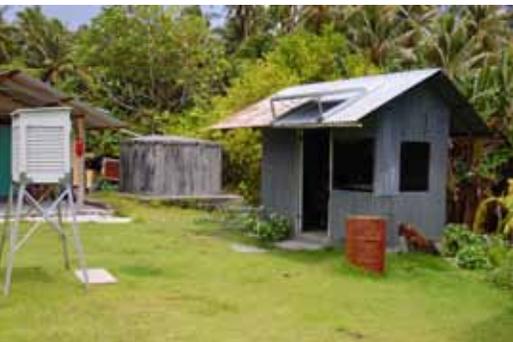
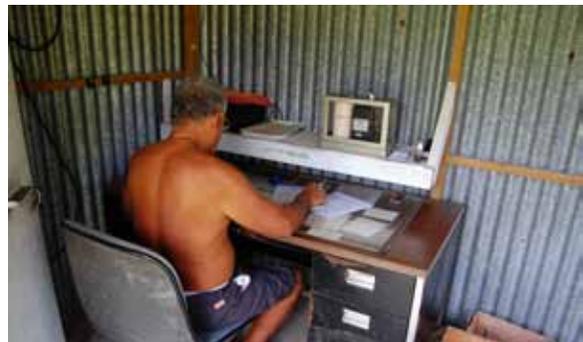
There is a small weather station on Mwoakilloa. It is operated by Galen Joel. The instruments available are barometer, thermometers (one measuring current temperature and the other recording minima and maxima), and a rain gauge. Anemometer was broken and sent to Pohnpei for repairs. Data is recorded every six hours and transmitted by radio to the Weather Service in Pohnpei. While anemometer is not available, wind speed and directions are estimated. This is risky considering that Mwoakilloa is served by small airplane from Pohnpei and accurate picture of the local wind conditions is vital to the pilots.

Fig 28
Meteorological
data collection
on Mwoakilloa.
