PITI-ASAN WATERSHED MANAGEMENT PLAN

Technical Report No. 138

September 2012

Hydrologic Unit Code (HUC) - 20100003-000-006

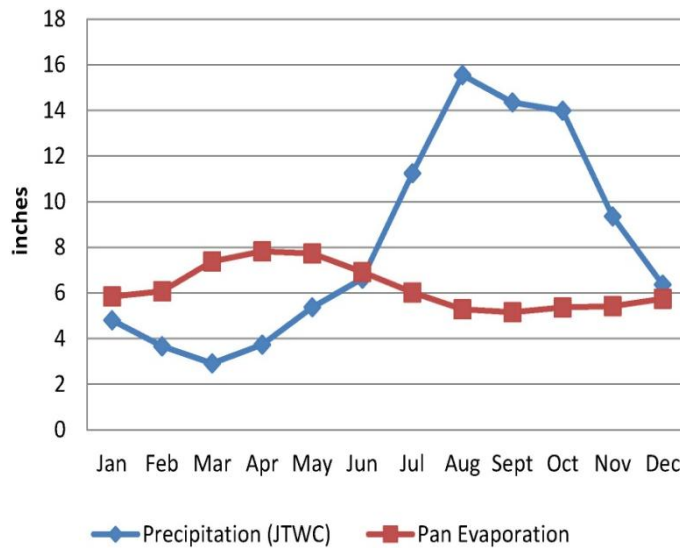
Figure 7. Comparison of rainfall and pan evaporation. *Source: WRCC, 2010.*

Monthly pan evaporation rates for Guam are available from the Guam Weather Service Meteorological Observatory in Finegayan (Dededo) from 1957 to 1998 (Figure 7 and Table 3). Pan evaporation rates in combination with a specific pan coefficient and crop coefficient can be used to determine unique evapotranspiration for different plants. Plant evapotranspiration indicates the water requirement of a plant to grow in a specific climate. During the dry season (Jan-Jun), when pan evaporation rates exceed precipitation, some plants may require irrigation for optimal growth. For that reason, planting is generally done sometime during the wet season.

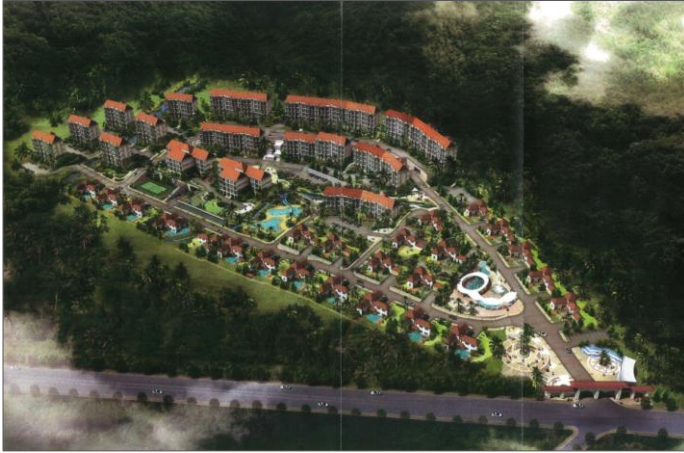
Figure 23. Model of the proposed JHP development.
Source: FC Benevente, 2007.

A 240-unit residential subdivision is planned on a 10-hectare (25-acre) lot east of Nimitz Hill Estates and Nimitz Towers (Figure 23). JHP Development intends to build 21 single-family detached homes, 22 two-story townhouses (86 units), 15 five-story condominiums (133 units), tennis courts, swimming pool, parking facilities, walking trails, convenience store, *etc.* (FC Benavente, 2007). The developer first applied for a zone change from agricultural “A” to multi-family residential “R-2” and a zone variance to the GLUC in 2007. Concerns by the Application Review Committee were primarily infrastructure-related (freshwater supply and wastewater system) and the proximity to the streams, which the developer wanted to address. The application was approved by the GLUC in May 2008. To date (July 2012), the property has remained undeveloped.

The proposed development lies on uneven terrain with steep slopes. The Asan River and a small unnamed stream pass through the property. A small pond that is located on the west side of the lot. The development, which may be up to 60 feet high, will be visible from many areas in the watershed (Figure 23), including the NHP Asan Units.

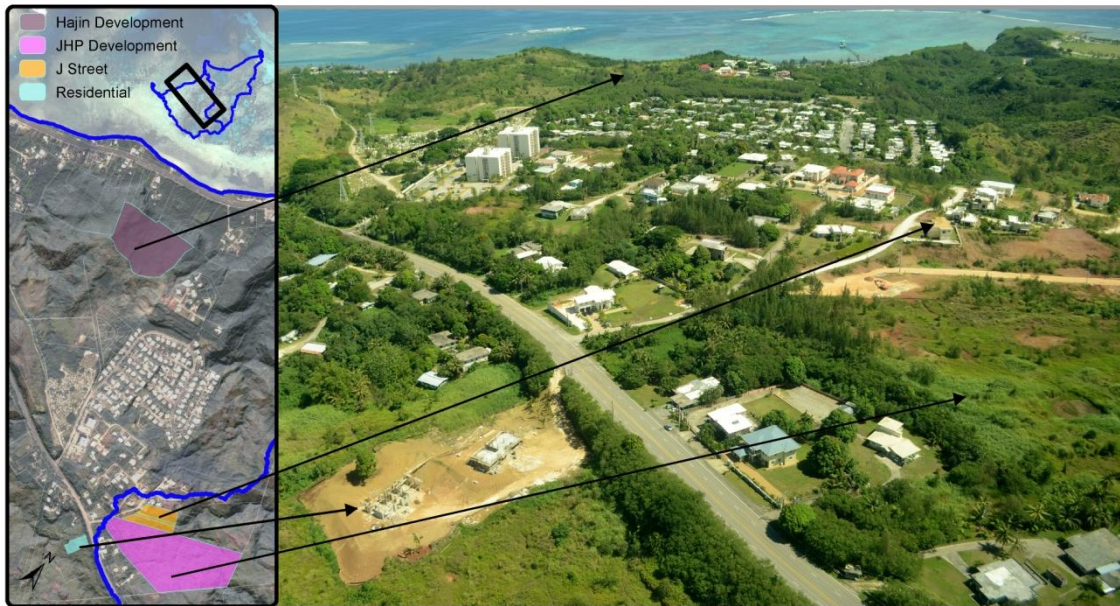
Figure 24. Map (left) and aerial view (right) of on-going and proposed development on Nimitz Hill. The aerial photo was taken June 20, 2012.

Two adjacent lots with a total size of about 1.5 acres across the entrance to Mama Sandy Road on Route 6 have recently been completely cleared and graded with steep slopes on the boundary (Figure 24). Two homes are currently being built on these lots.

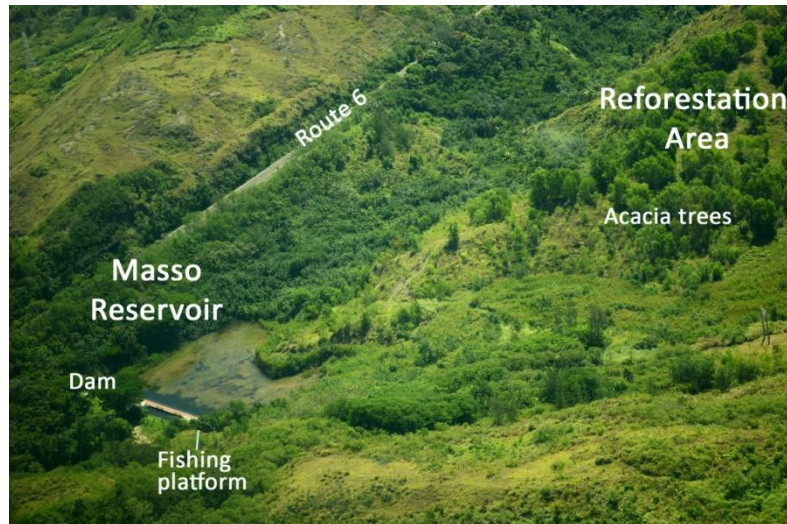
Figure 28. Aerial view of Masso Conservation Area. Photo was taken June 20, 2012.

The Masso Reservoir was constructed by the Navy in 1945 by damming the Masso River (Tibbatts, pers. comm.). It was only used as a water supply until 1951 because of severe sedimentation problems (Wiles & Ritter, 1993). Between 1978 and 1982, DAWR upgraded the site by repairing the spillway, removing Phragmites, planting exotic plants, and stocking the reservoir with fish for public fishing. In 1983, the management program was stopped because of vandalisms and illegal fishing methods (Wiles & Ritter, 1993). In 1999, the local government planted about two acres with Acacia trees, which mostly established well (Figure 28). In 2004, extensive improvement and restoration efforts of the reservoir and adjacent area began (Tibbatts, pers. comm.). Since the recent completion of the restoration work, the Masso conservation area has attracted an increasing number of recreational fisherman, hikers, and campers.

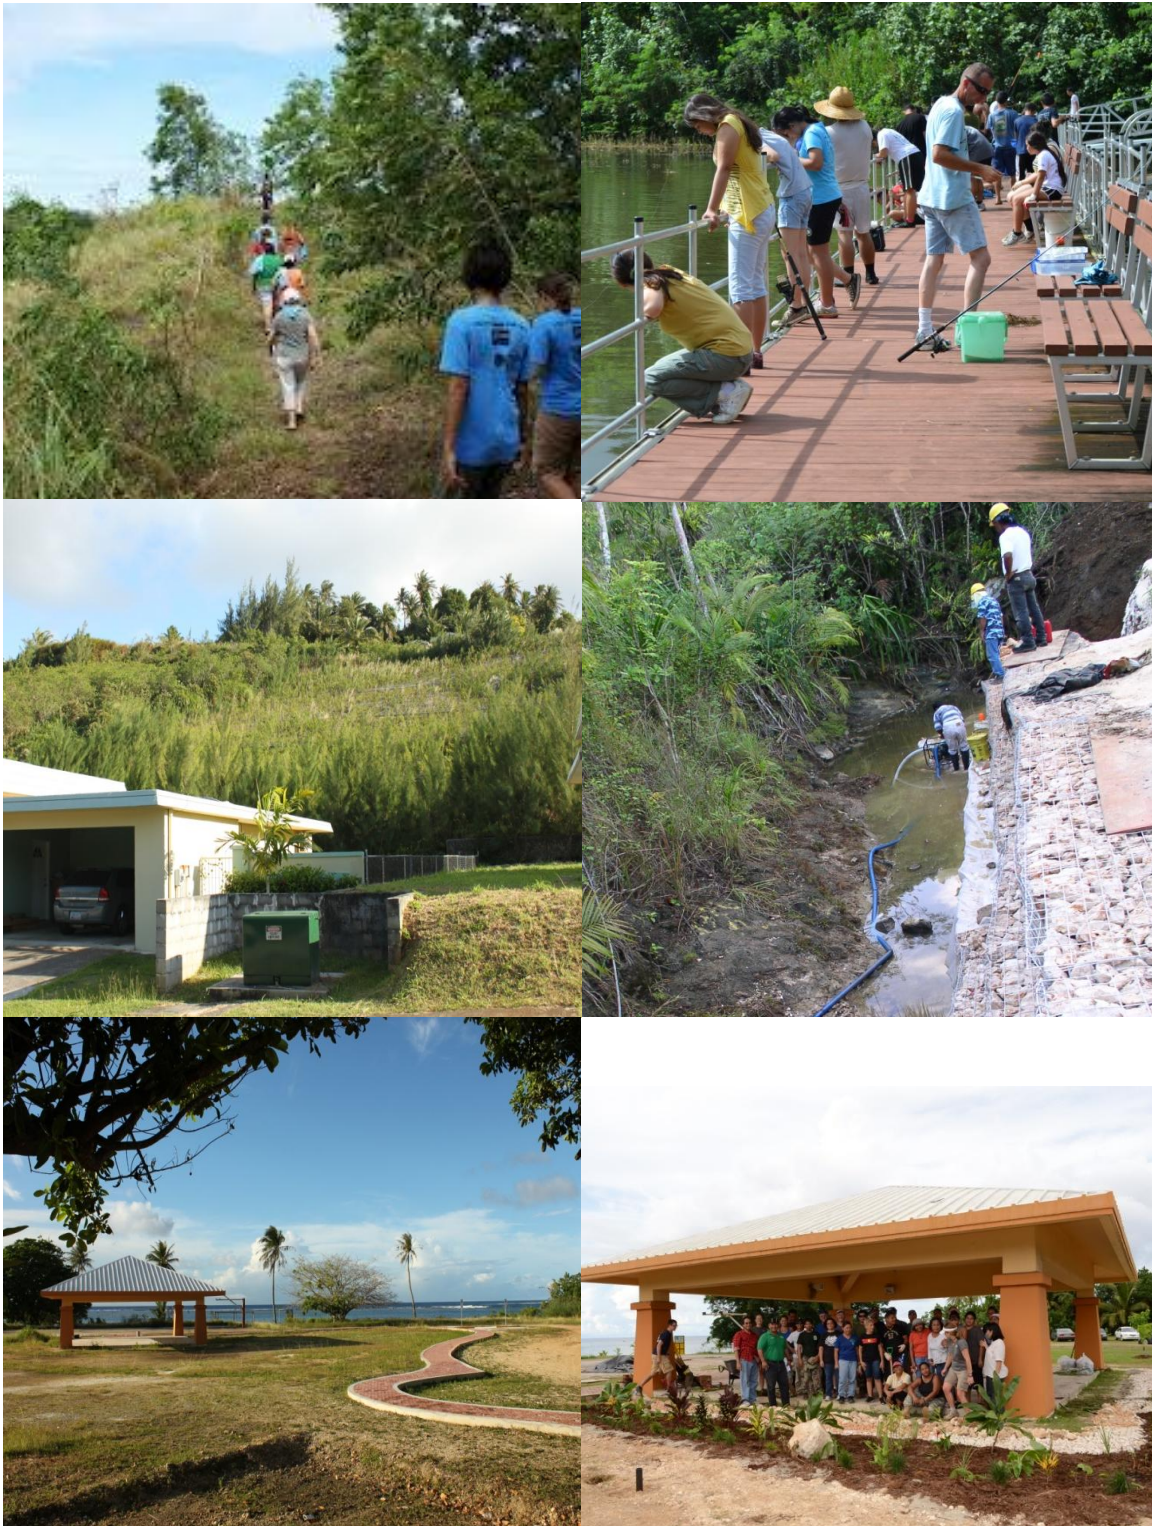
Figure 29. Examples of restoration sites in the Piti-Asan watershed. From top left to bottom right: re-vegetation site in Masso watershed above the reservoir; Masso Reservoir with fishing platform; slope stabilization site (behind house) of 2004 land slide; NRCS streambank protection with gabions; Pedro Santos Memorial Park improvements; and raingarden installation at Pedro Santos Memorial Park.

The following section describes completed and on-going restoration projects in the Piti-Asan watershed. Some of the projects are also shown in Figure 29. A summary of all the projects listed here as well as proposed projects can also be found in Table 26 on pages 67-69. The map IDs listed here refer to Figure 40 on page 70.

This project was conducted in response to the damage of Tropical Storm Tingting in 2004. The streambank was stabilized with gabions to protect the property (including the sewage line from the house) and to prevent sediments flowing into the river (Wheaton, pers. comm.).

This project was in response to a serious landslide on Sanhilo Circle in the Nimitz Hill Estates also caused by Tropical Storm Tingting. After investigation by NRCS experts (Garjo, 2005), the slope was stabilized with a combination of “hard” and “soft” techniques.

A raingarden workshop was held September 7, 2012. The one-day workshop included presentations and hands-on installation. Over 40 people from various governmental agencies and the community participated. The raingarden was installed on three sides of the pavilion encouraging infiltration of the roof runoff. The raingarden is a slightly depressed area filled with sand, compost, and mulch and planted with various mostly native plants. It includes also a slightly slanted ditch filled with small rocks to convey the roof runoff to the raingarden.

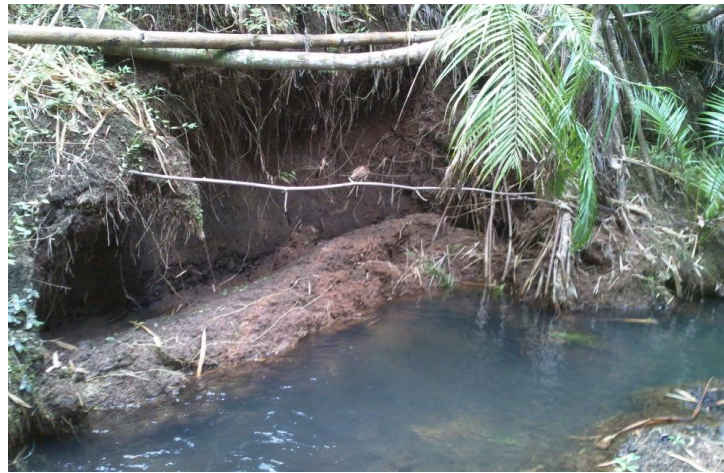
Figure 34. Example of streambank erosion in the lower part of Asan River. *Photo courtesy of Amanda DeVillers.*

Sediments from actively eroding streambanks might be the biggest contributor to sediments in the streams and marine environment in the watershed. Severe streambank erosion has been observed in the Asan River (deVillers, pers. comm.) and in the Masso River, but is likely to occur in the other rivers in the watershed as well (Figure 34). Streambank erosion is a serious concern since the eroded sediments cannot be trapped by plants, and are almost instantly transported into the river. In contrast, sediments from upland erosion might be trapped in depressions known as sediment sinks or by vegetation and not be transported into the streams.

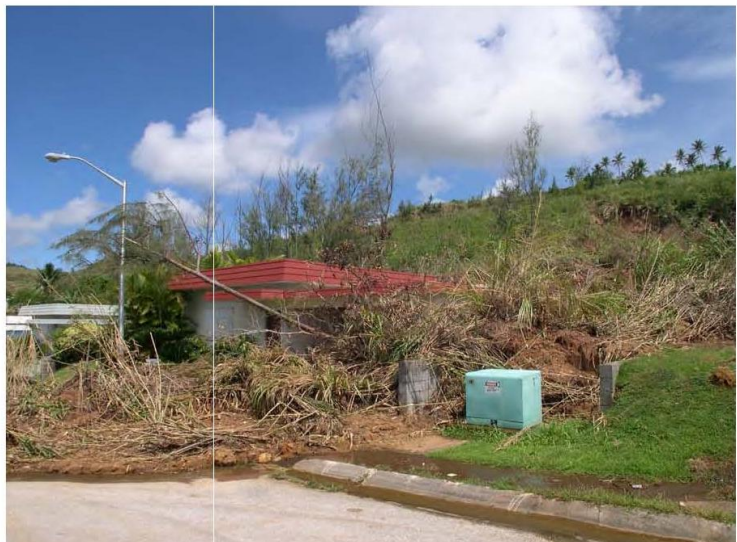
Figure 35. Landslide at Nimitz Hill Estates that occurred when Tropical Storm Tingting hit the island on June 27, 2005. *Photo taken July 12, 2007 by Robert Gavenda, (Marshall-Garsjo, 2005).*

Due to the nature of the volcanic substrate, certain areas in the watershed are prone to mass wasting. Especially during high rainfall events, as common during tropical cyclones, the upper more permeable soil layer can become saturated and slope failure can occur (Doerge and Smith, 2008). A serious land slide affecting several houses on Sanhilo Circle in Nimitz Hill Estates occurred on June 27, 2005, after Tropical Storm Tingting struck the island (Figure 35). The slope was later stabilized by NRCS (see also Appendix C). Another serious landslide occurred on the cliff side close to Adelup several years ago. A scar in the vegetation is still visible today. Apparently, a homeowner built too close to the cliff, cutting into the toe of the slope, undermining its stability.

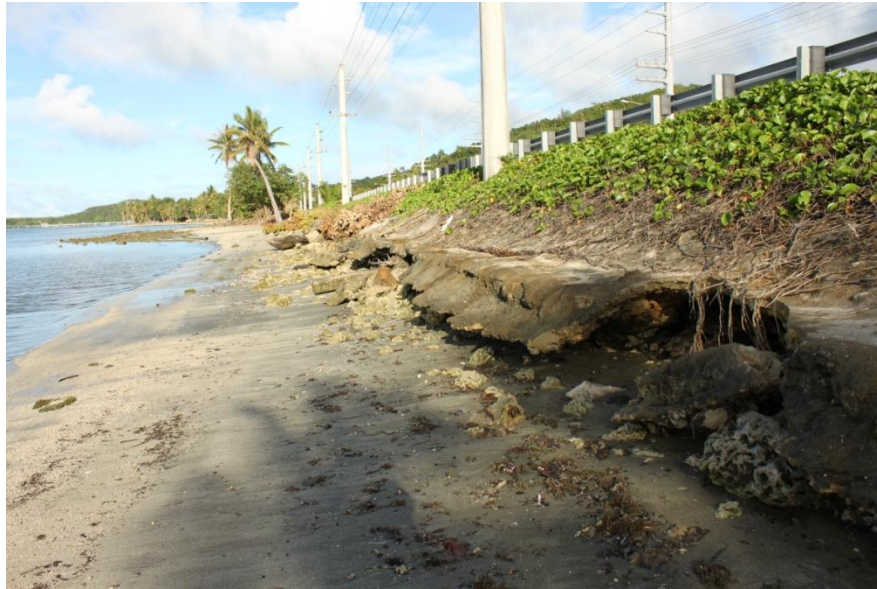
Figure 36. Eroding shoreline along Piti. Concrete was poured over limestone to stabilize the shoreline; structures are eroding and may affect the road soon.

Erosion along the Piti-Asan shoreline is a problem common on many beaches on southern Guam. Almost the entire shoreline of the watershed consists of stretches of sand beaches. Only few areas, like Adelup Point, Asan Point, and Cabras Island have a rocky shoreline. Remnants of former structures, exposed roots, and undercut shoreline are evidence of the retreating shoreline. Previous efforts of stabilizing the shoreline proved inefficient (Figure 36). The area should be monitored closely and measures need to be taken before the erosion affects Marine Corps Drive. Three specific stretches in Piti along Route 1 were identified as candidates for highway shore protection in a report by Sea Engineering, Inc. (2007).

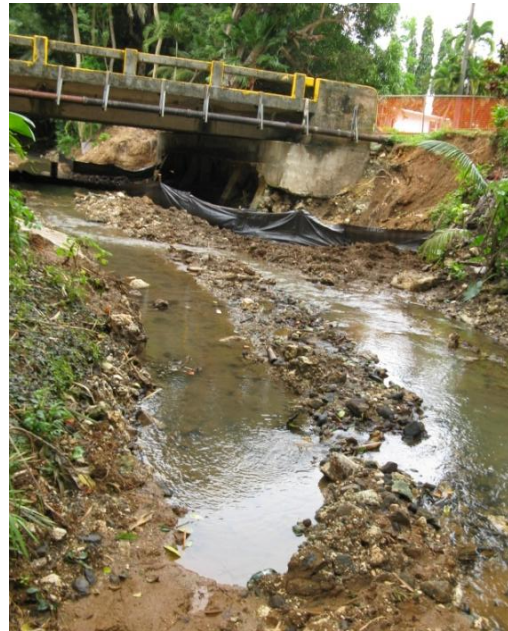
Figure 37. Example of a poor construction practice at the Masso bridge. A backhoe drove into the river bed destroying the river bed structure. Sediment fences along the bridge were only installed after the contractor was cited. *Photo courtesy of David Burdick.*

Poor construction practices are a major threat to water quality as erosion and sediment control are frequently overlooked during the construction process. Often, contractors fail to install adequate control measures and only rectify the situation if citations or stop work orders are issued (Figure 37). Without proper erosion and sediment control, large amounts of sediments can enter the waterways.

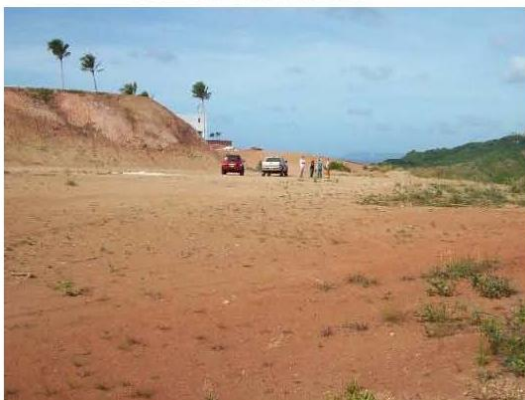
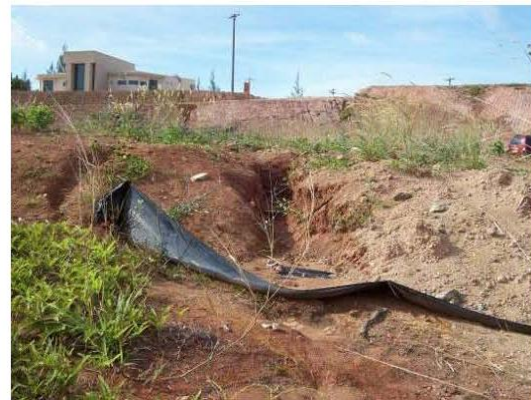
Figure 38. Exposed soil (left) and deep gullies (right) on a development site on J Street on Nimitz Hill in 2008. Silt fences were not effective as they did not trap the eroded sediments from the gullies and nearby areas. *Photos courtesy of CWP/HW (2010).*

Current Guam Soil Erosion and Sediment Control Regulations (PL 25-152) focus mostly on construction-related sedimentation and stormwater management but have little to no post-construction requirements. However, revisions to these regulations, currently under review, include managing post-construction stormwater runoff from new land development and/ or re-development which needs to be contained on-site or adequately treated to meet current water quality standards before discharging it off-site. The large development on J Street (Figure 38) is documented in a time series 2003—2009 in Appendix C.

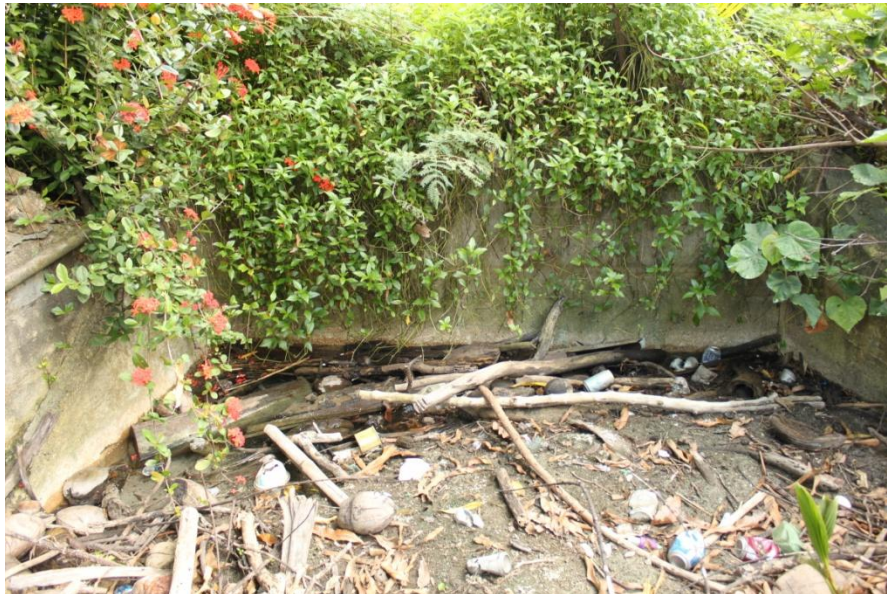
Figure 39. Clogged culvert along Marine Corps Drive in Piti.

Improper stormwater management not only degrades water quality but may cause or exacerbate flooding problems. An example of improper stormwater management is shown in Figure 39. Some areas in Piti village have flooding problems; at Jose L.G. Rios Middle School classrooms frequently flood during heavy rains (see Appendix E).

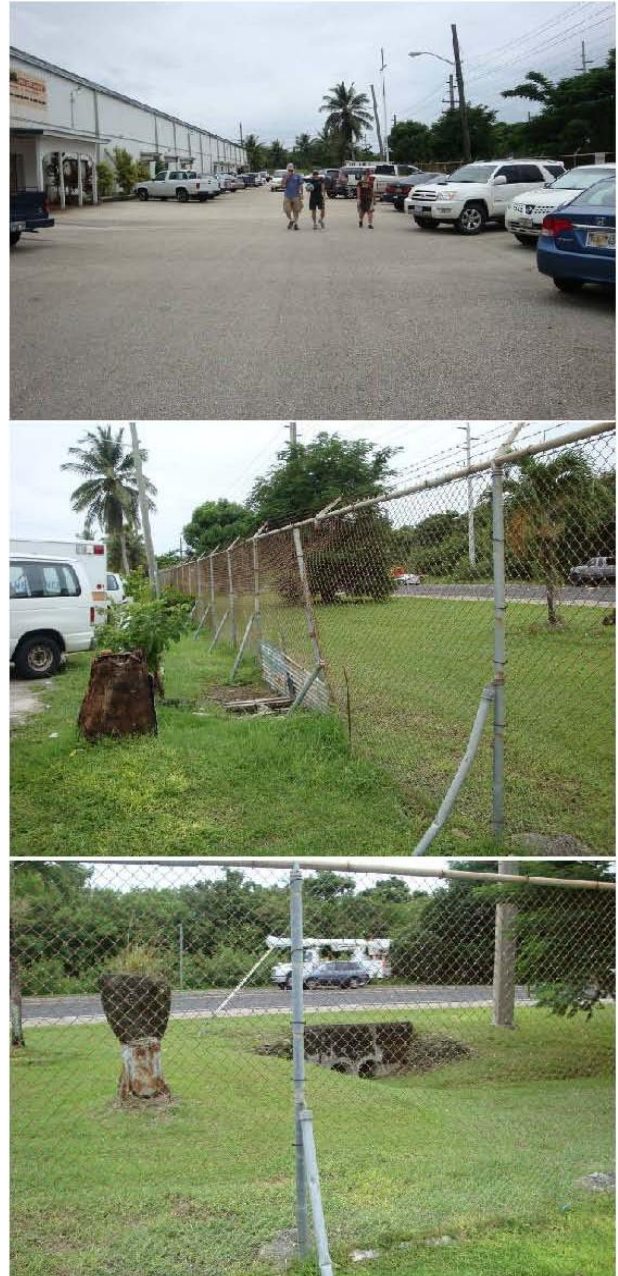
Figure D-1. Runoff from portion of rooftop and front parking drain to grassed area, then through culvert under Marine Corps Dr.

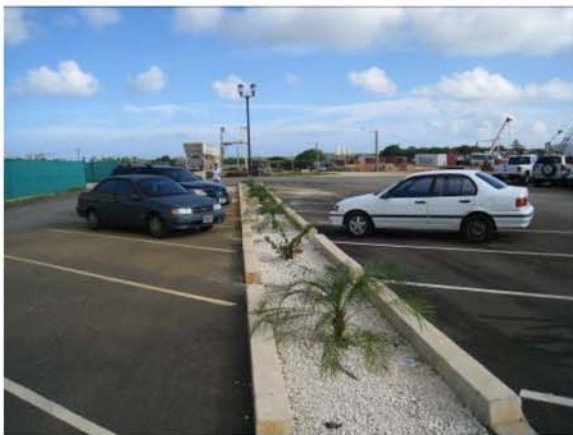
Figure D-3. Example of a parking lot bioretention area in Guam.

Figures D-3 and D-4 show examples of various bioretention areas and rain gardens.

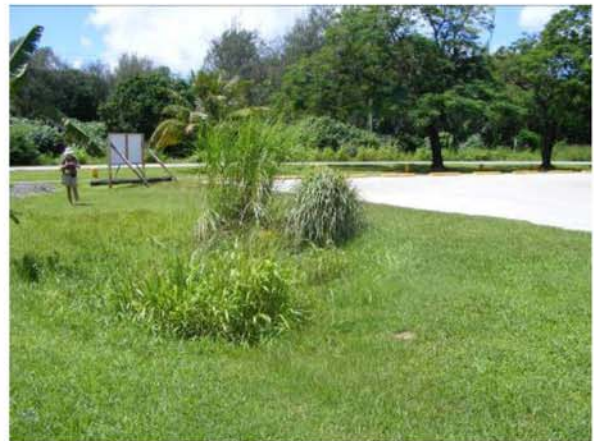
Figure D-4. Example of a rain garden treating parking lot runoff in Saipan.

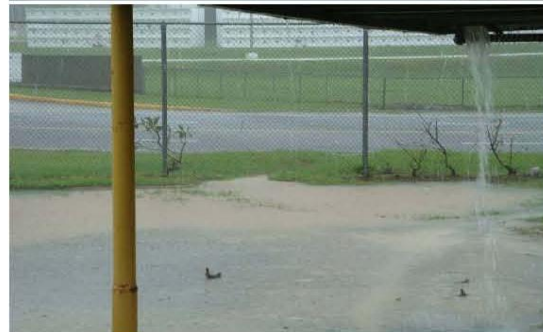
Figure B-5. Sediment in runoff is conveyed over the courtyard, into a channel then trench, and continues out across the parking lot. Runoff leaves the site and enters the street conveyance system (ditch), carrying sediment to the bay.

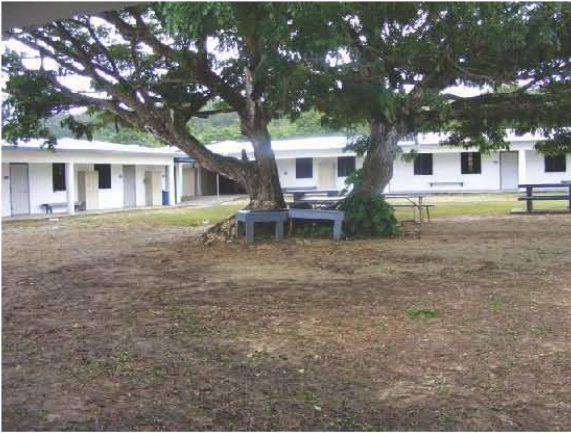
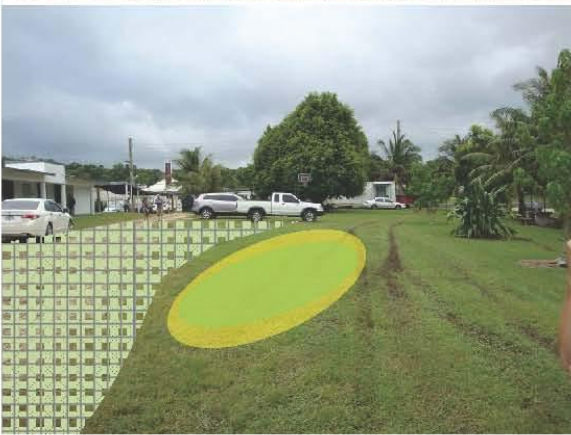
Figure D-6. Existing site conditions and proposed location of the retrofit.

In order to reduce stormwater sediment loads, the courtyard areas should be stabilized with mulch (Figure D-6). Construct a drainage channel with a grate top to convey runoff out of the courtyard and around the front of the school. Continue this trench around to the large grassed area adjacent to the dirt parking lot. Construct a rain garden with 1-2 feet of ponding depth to capture and treat the conveyed runoff. Additionally, replace the dirt parking lot with grassed permeable pavement (Figure D-7).

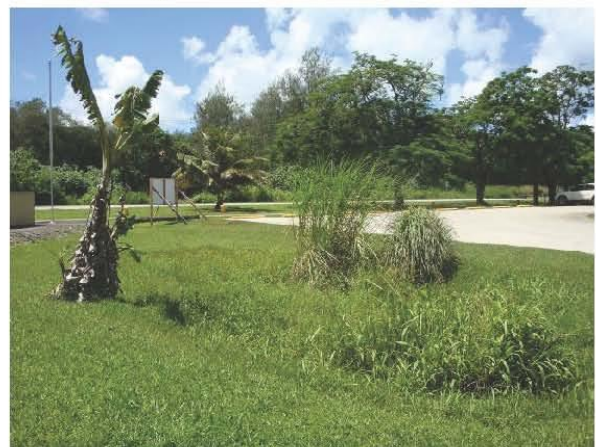
Figure D-8. Example of a rain garden in Saipan.

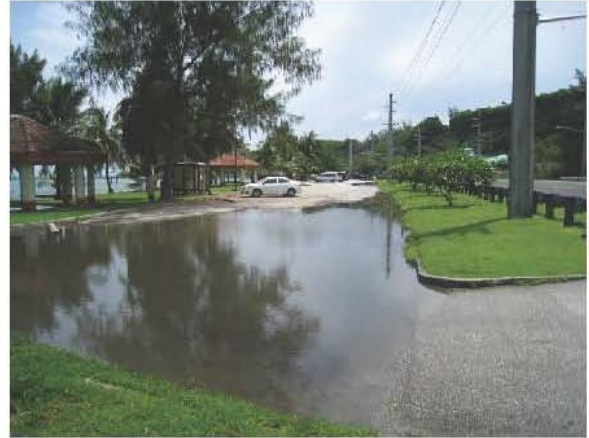
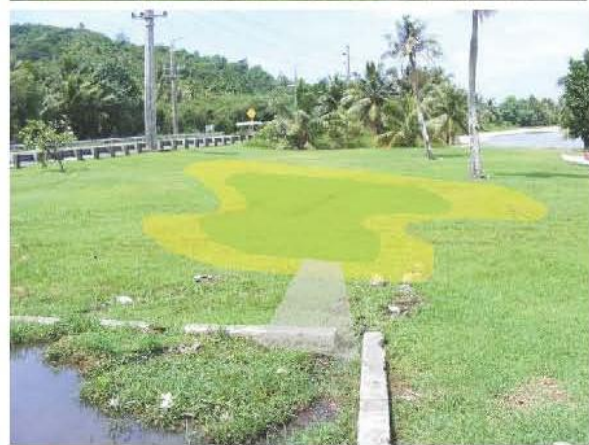
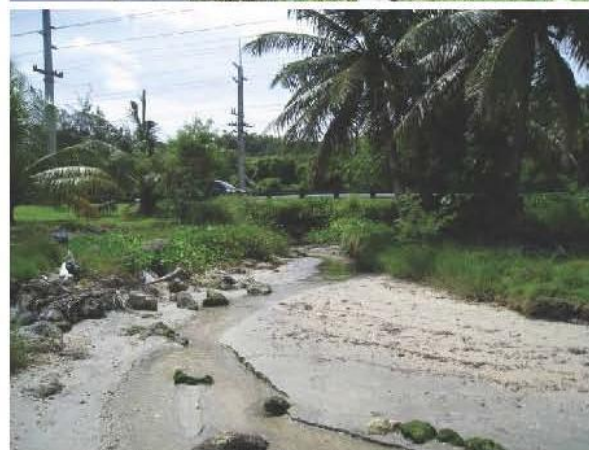
Figure D-9. Images of the flooded parking lot area (top), adjacent open space for a proposed wetland (middle), and the roadway outfall channel (bottom photo).

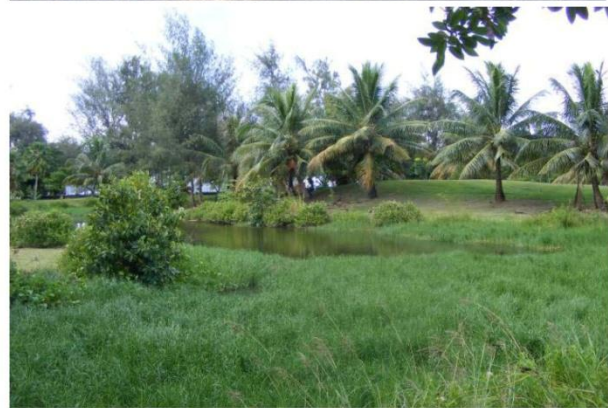
Figure D-11. Example of a wetland treating parking lot runoff in (upper photo) and wetland plantings in a stormwater channel (lower photo) in Saipan.

Project examples are shown in Figure D-11.

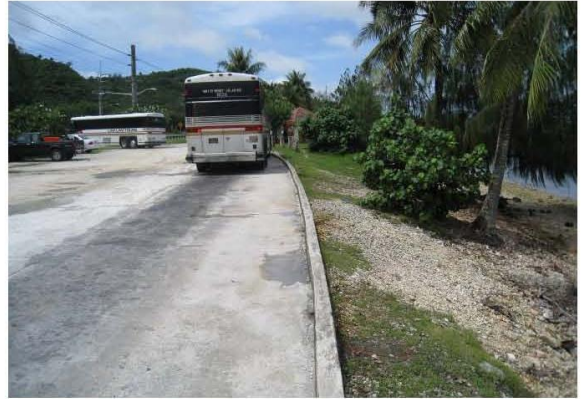
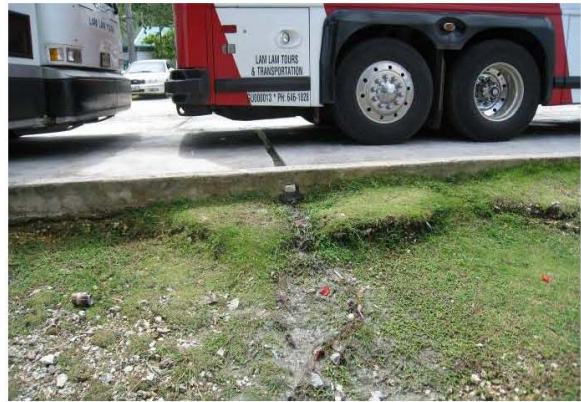
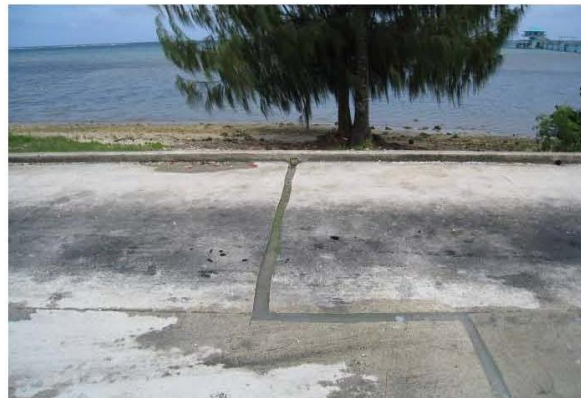
Figure D-12. Runoff from the concrete bus loop is conveyed across the concrete pad via grooves and sheetflow, and discharges through square notches in the curb to the nearby beach and water. There are oil stains on the concrete pad and bus exhaust deposits other pollutants on the concrete.

Runoff from the concrete bus loop and parking lot drains directly to the beach and water. There are several grooves in the concrete that drain runoff through slots in the concrete curb. There are many oil stains in the area, and the bus exhaust also deposits pollutants onto the concrete. There is currently no filtering or treatment mechanism for the pollutants (see Figure D-12).

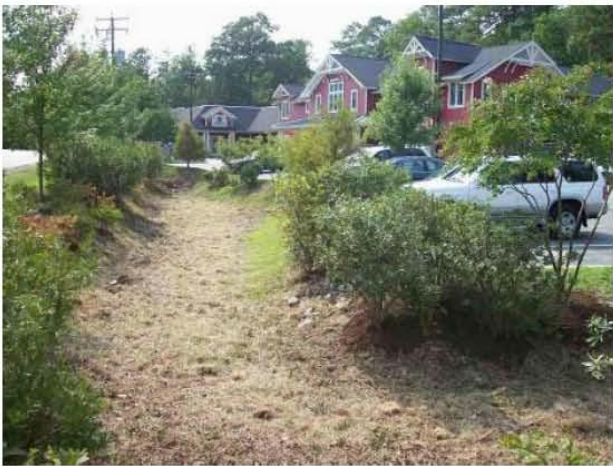
Figure D-14. Example of a surface sand filter treating parking lot runoff.

Figures D-14 and D-15 show examples of two types of sand filters.

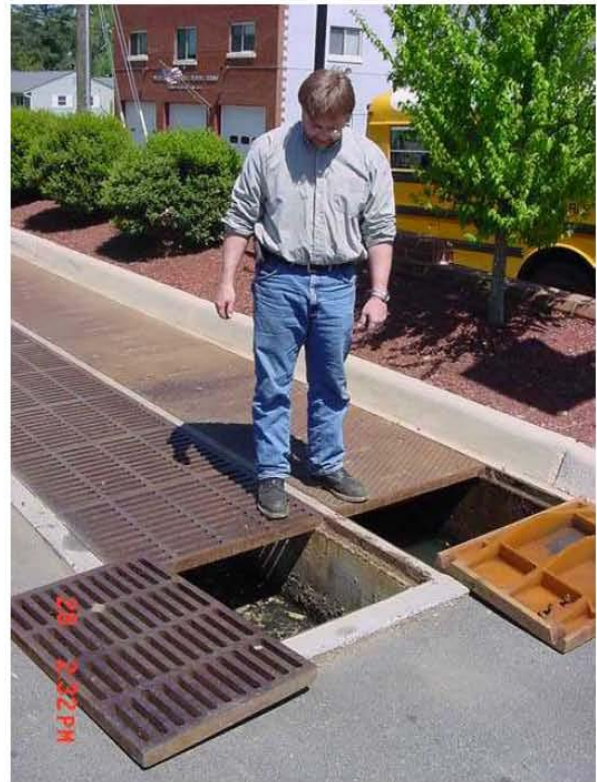
Figure D-15. Example of sand filter with grate top. The grates provide maintenance access.

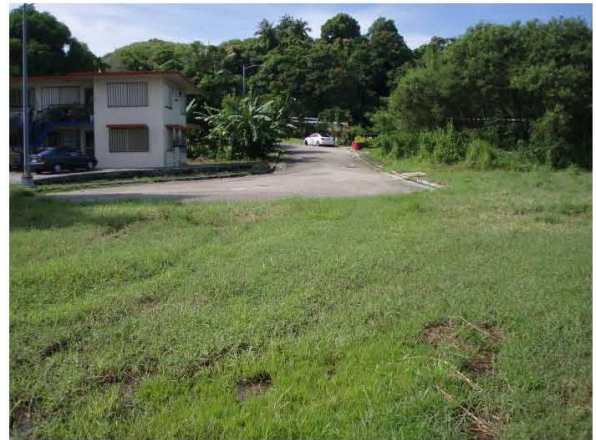
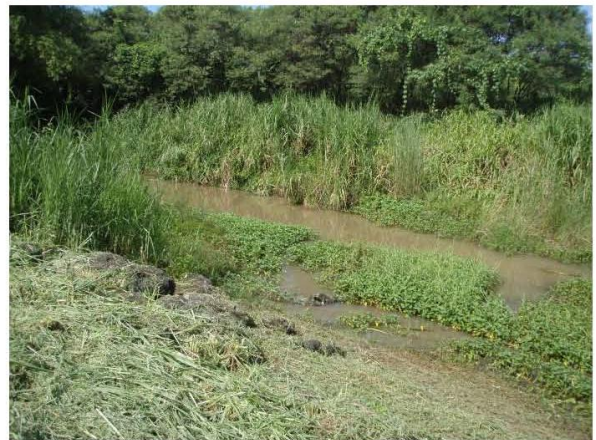
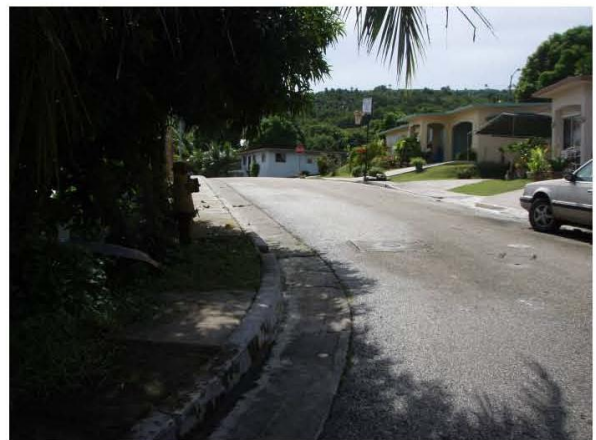
Figure D-16. Open space area for community bioretention (top). Plant native trees and buffer vegetation along Asan River (middle). Notice turbid flow in stream. Runoff to cul-de-sac is generated on Limitaco St. and includes residential driveways and, in some cases, rooftops (bottom).

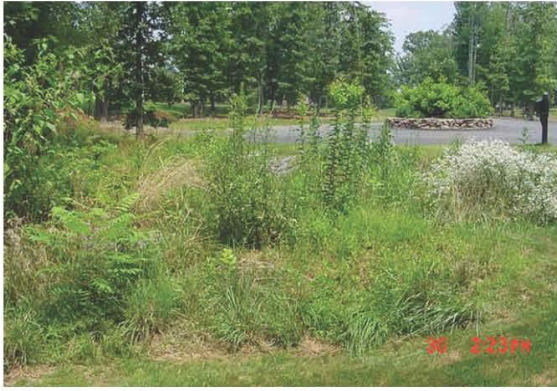
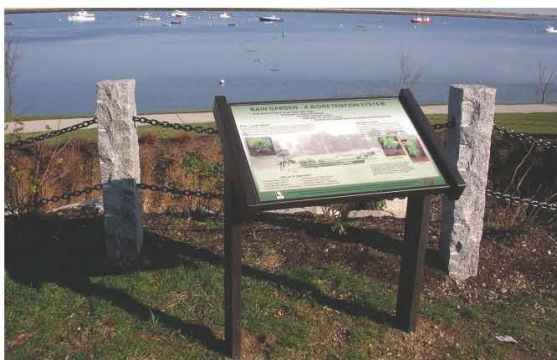
Figure D-18. Example of a large bioretention facility collecting runoff from a cul-de-sac and educational signage describing a rain garden along the waterfront (bottom).

Figure 18 shows examples of a bioretention facility at the end of a parking lot and educational signage. While these are examples from mainland US, they can be adapted for Guam.

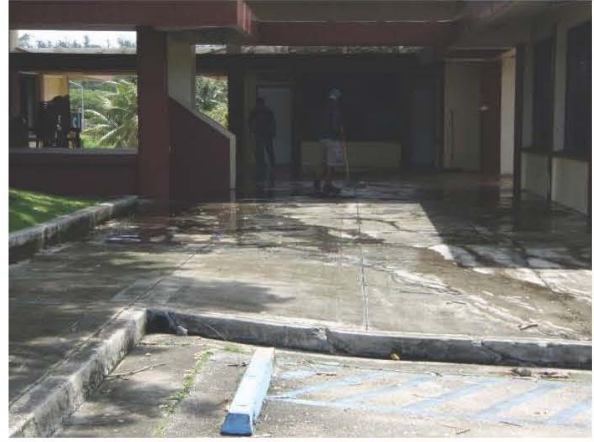
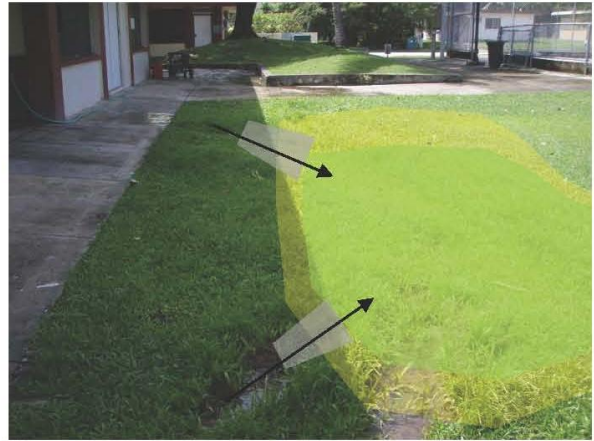
Figure D-19. Rooftop downspout through curb and onto parking lot. Washwater drains to parking lot, which drains to river (top). Proposed rain garden location in rear where roof leaders open into grassed area (lower).

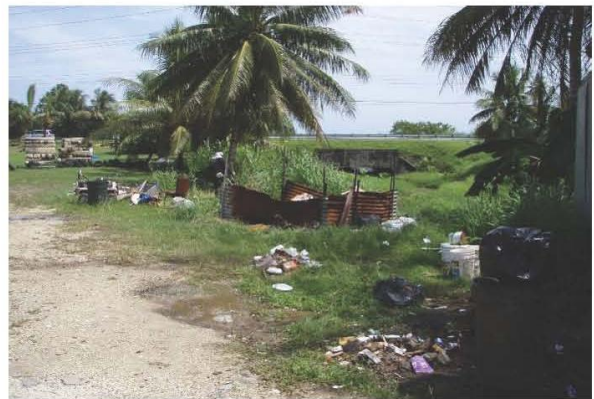
Figure D-20. Debris piles along river buffer.

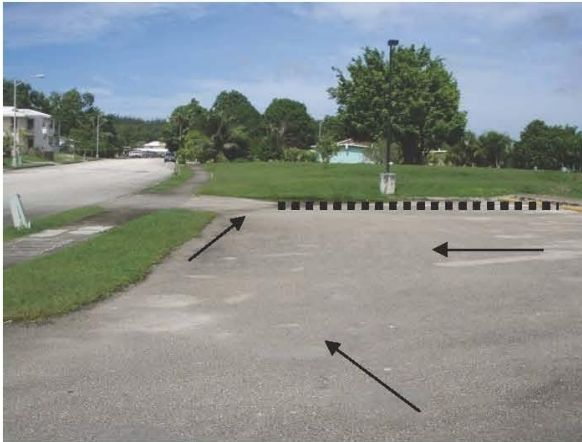
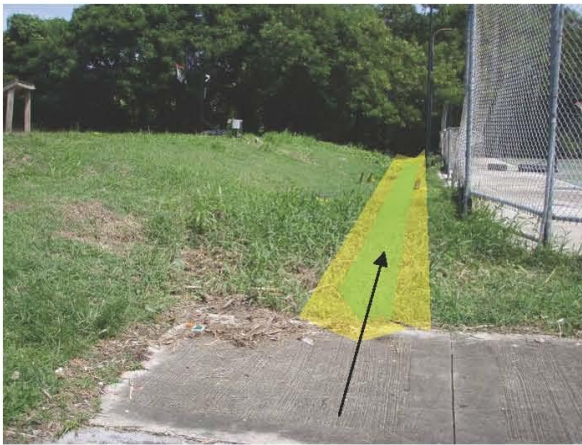
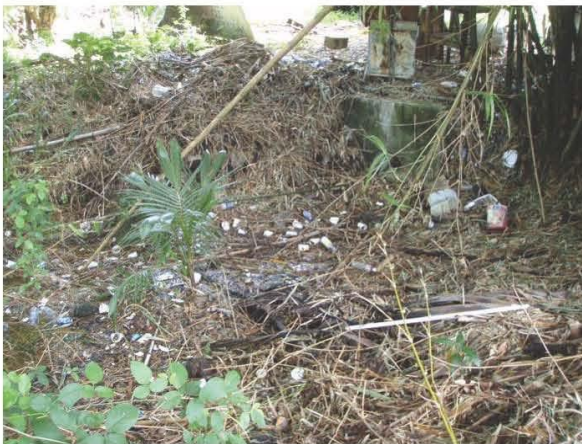
Figure D-21. Water collects in small side parking lot. Install trench drain to convey water to existing swale (top photo). May need to excavate swale to appropriate depth for trench drain invert to achieve positive drainage. Enhance swale with vegetation (middle). Trash in wetland area (bottom).

Grade and elevations of side lot may make getting runoff into swale difficult. Trench drain can have reverse slope, but swale may require additional excavation to obtain proper invert. The design should consider an appropriate method for crossing the existing sidewalk.

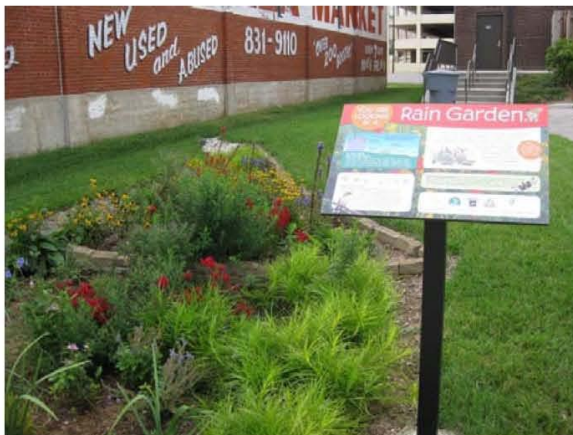
Figure D-23. Example of a small rain garden collecting rooftop runoff and accompanying signage explaining the benefits of this type of on-site stormwater management.

Figures D-23 and D-24 show examples of a rain garden and a trench drain. The rain garden for the Asan Community center should use local plants.

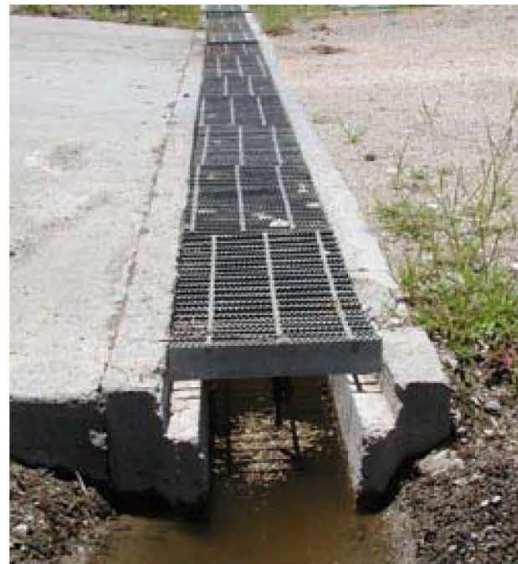
Figure D-24. Example of a trench drain that can be used to convey runoff from parking area to bioswale.
